## IMPACT RESISTANCE OF STRUCTURAL CERAMICS

### Part II: BALLISTIC TESTS

TECHNICAL REPORT AFML-TR-76-56, Part II  
FINAL REPORT FOR PERIOD JUNE 1975 - FEBRUARY 1976

AIR FORCE MATERIALS LABORATORY  
AIR FORCE WRIGHT AERONAUTICAL LABORATORIES  
AIR FORCE SYSTEMS COMMAND  
WRIGHT-PATTERSON AIR FORCE BASE, OHIO 45433

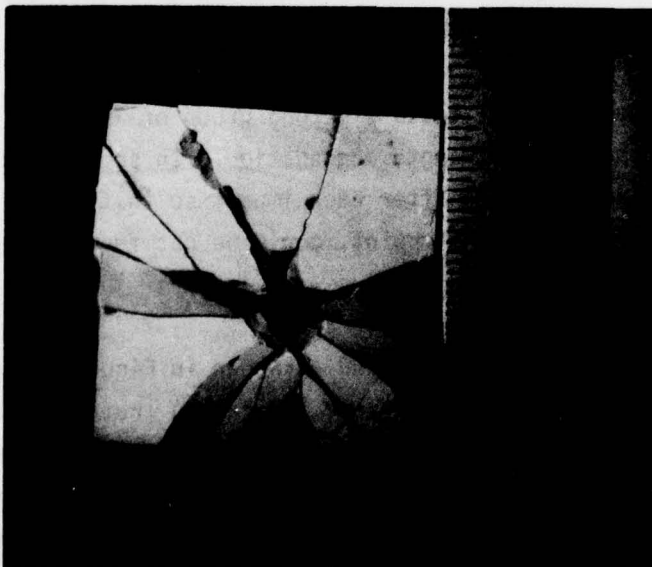
Figure 7. Flexural Failure, 0.125" Thick  $\text{Si}_3\text{N}_4$  (NC-350) Ring Support,  
1300°C Back Face, (a) 187 f/s, (b) 184 f/s

These specimens were only 0.125" thick and therefore no direct comparison with the 0.2" thick specimens of other materials can be made. In addition, the low fracture velocity (<100 f/s) in the ring support made it impossible to determine the critical value since the air gun could not be controlled at such low velocities. Figure 7 shows the type of fracture that was observed at 1300°C.

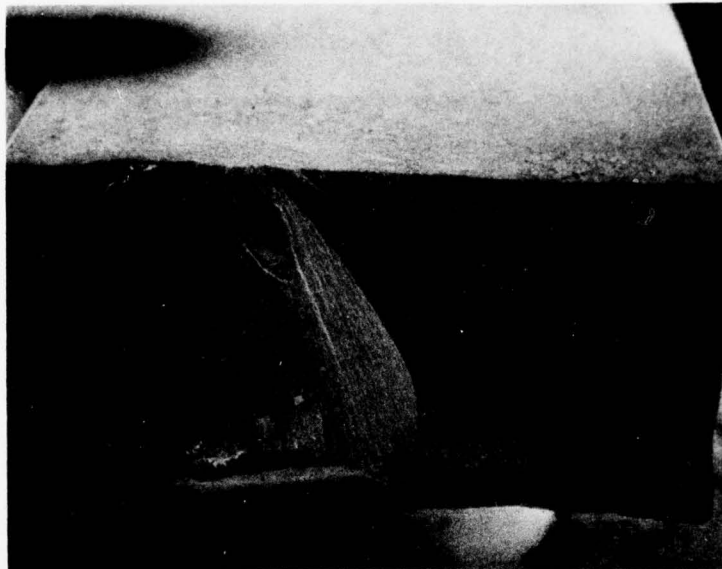
Figure 9. Hertzian Cone Crack on Fracture Surface of 0.1" Thick Bend Bar,  $\text{Si}_3\text{N}_4$  (NC-132), Anvil Support, (a) 926 f/s, (b) 825 f/s
